152–164 Bathurst Street and
623–627 Richmond Street West
Toronto, ON

Preliminary Hydrogeological Impact Assessment

PGL File: 5660-03.03

April 2021 v1

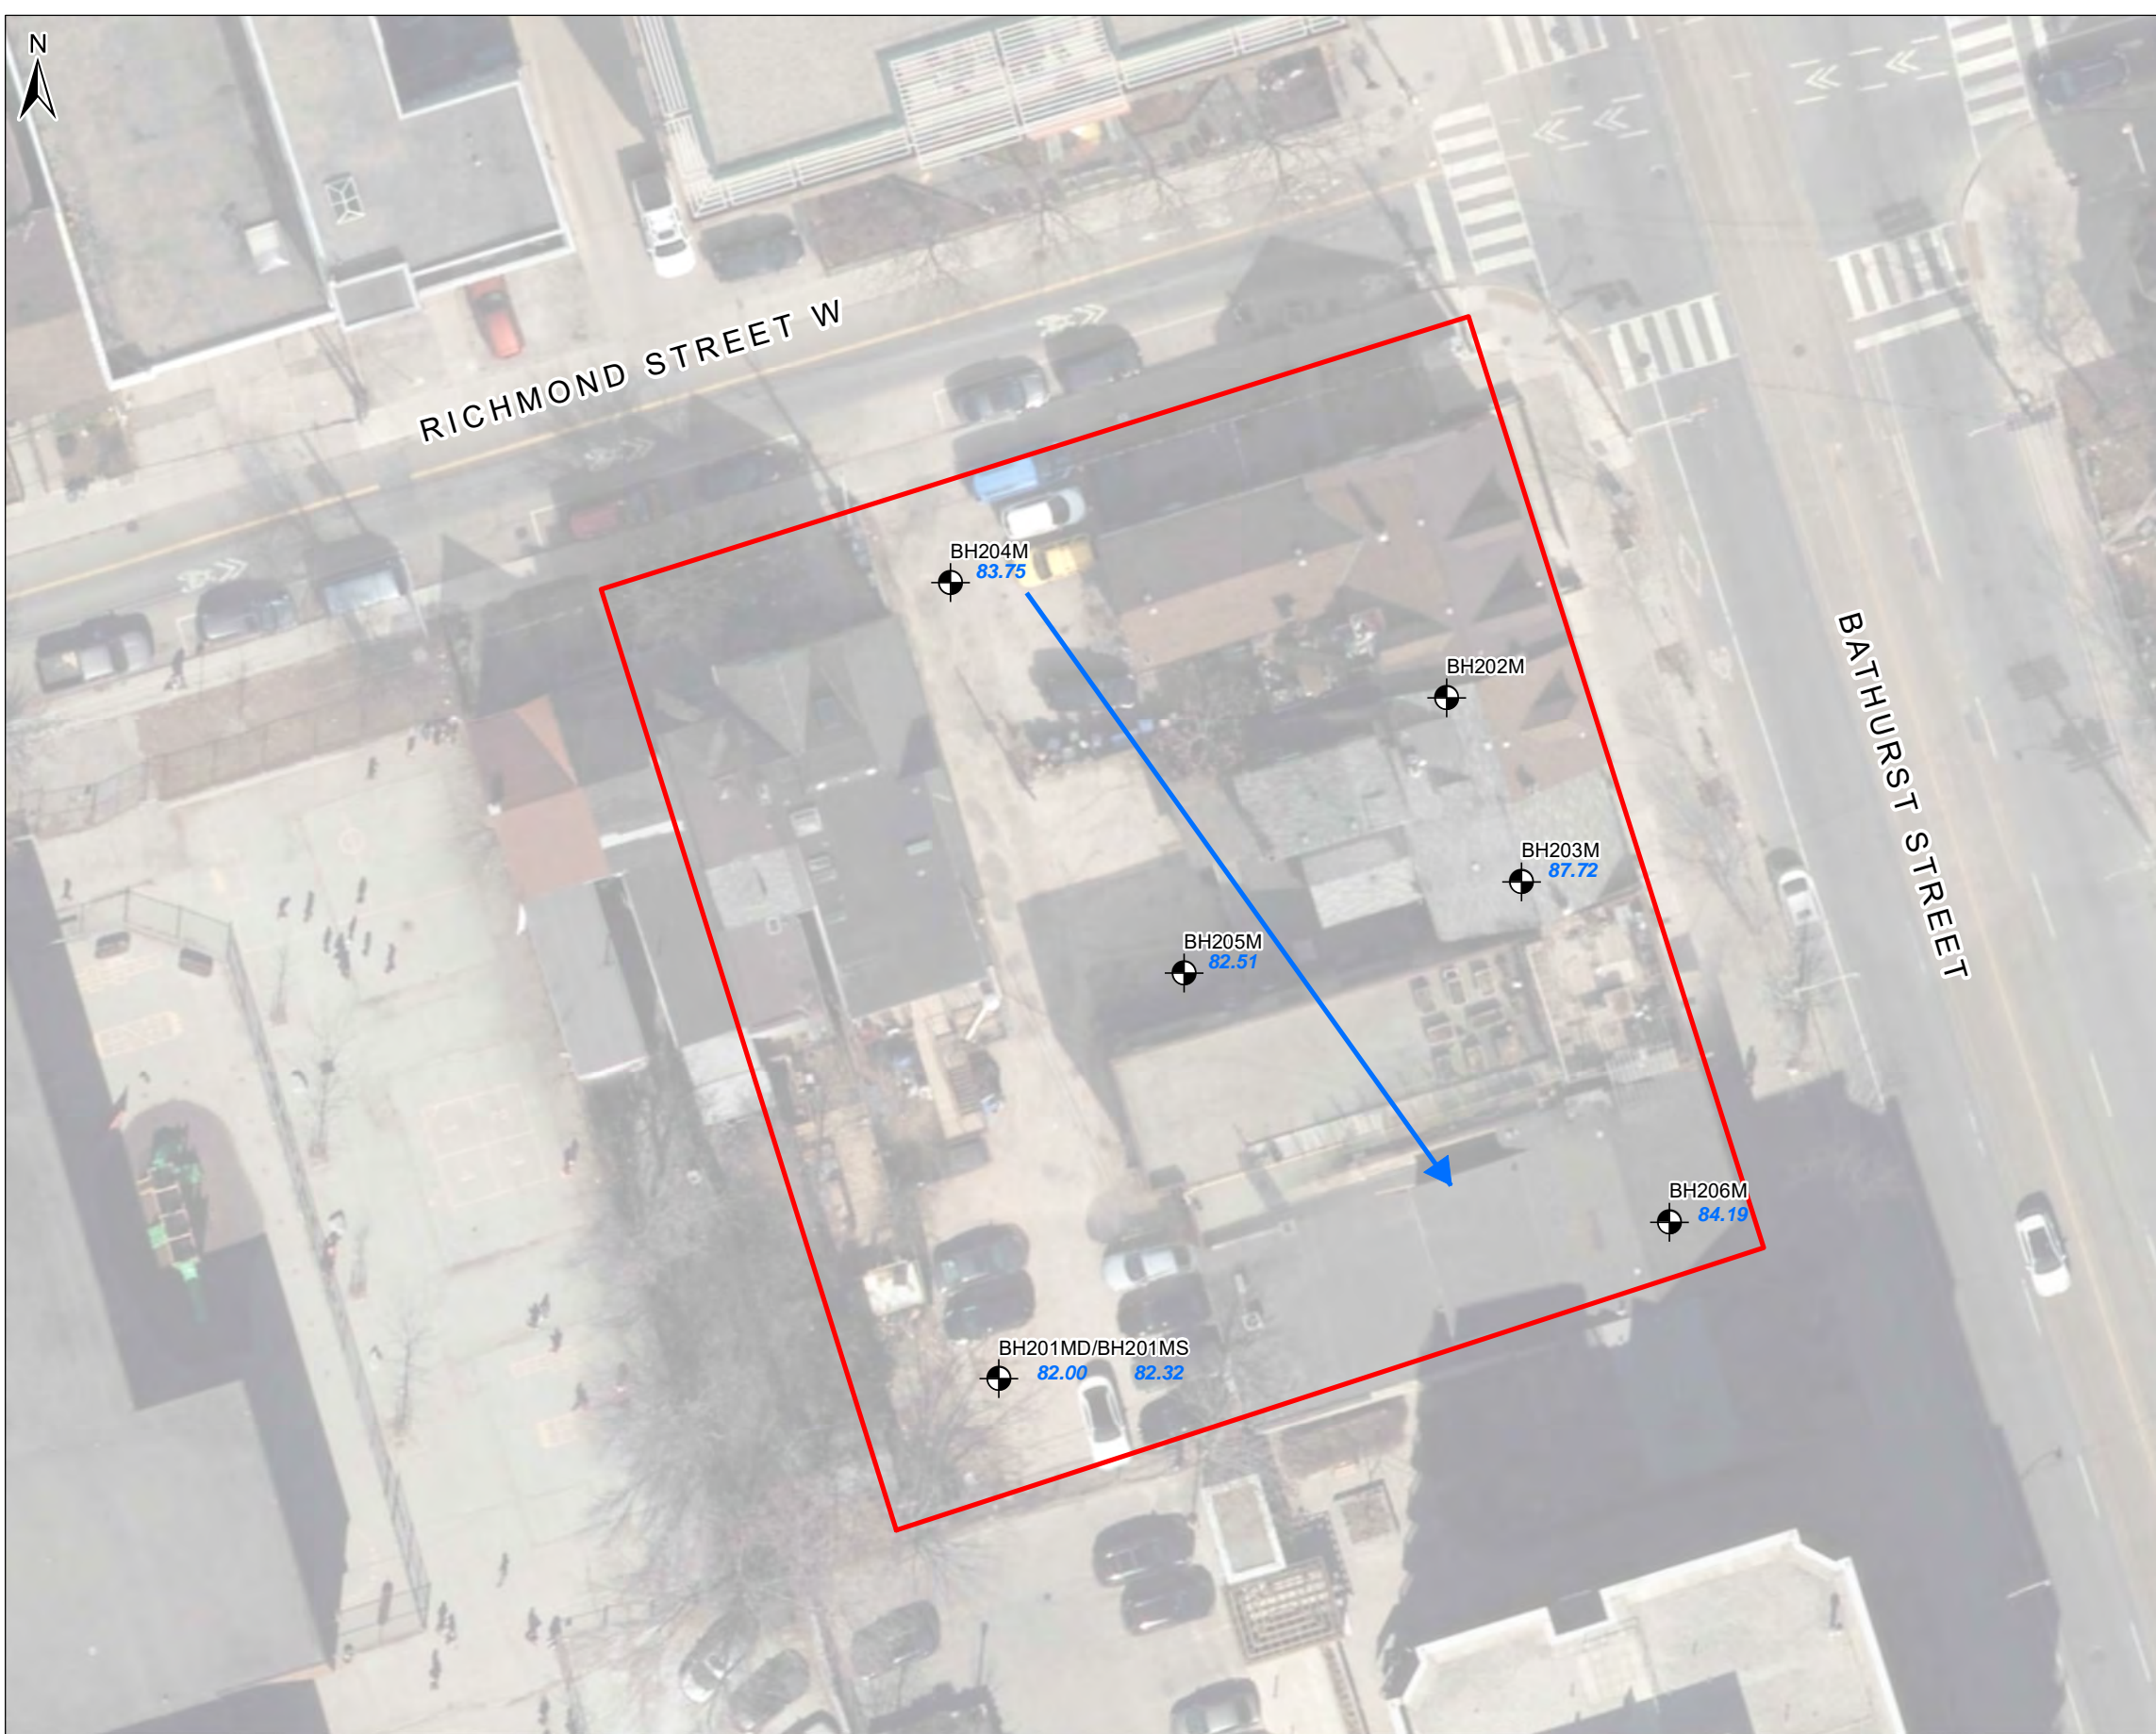
File No.:	Dwg No.:	FIGURE
	Date:	Drawn by:	
	5660-03.03	HG_0020	2
	APR 2021	RSS

- Site Boundary (Approximate)
- ➔ Inferred Groundwater Flow Direction *
- ### Groundwater Elevation (m asl)
- ⊕ Monitoring Well

* GROUNDWATER TABLE IS STILL RECOVERING. GROUNDWATER FLOW DIRECTION INFERRED TO BE SOUTH TOWARDS LAKE ONTARIO

- Groundwater elevation ranged between 80.88m asl to 87.72m asl between March 9 and 25, 2021;
- The excavation will extend down to an elevation of 79.56m asl, within the silty clay till, and dewatering is required to an elevation of 78.56 asl; and
- The hydraulic conductivity is based on published literature associated with soil stratigraphy, where the water table was observed, and where the excavation will extend is $1.0 \times 10^{-8} \text{m/s}$.
